Why do other muffles fail before Alloy Engineering muffles?

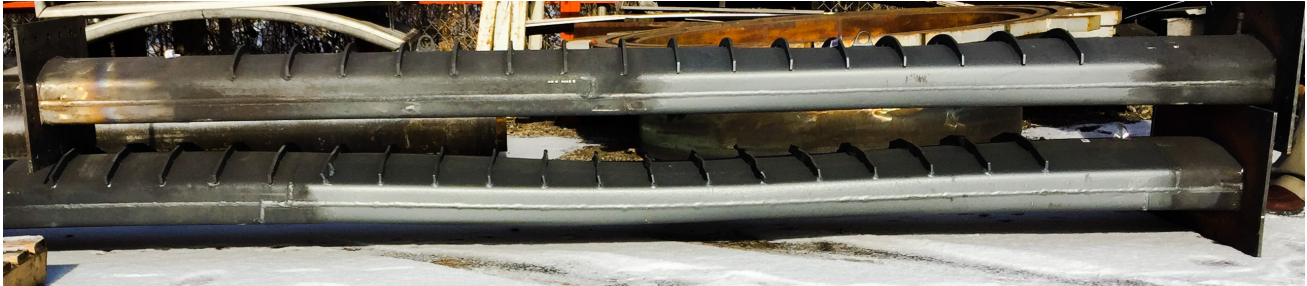
Pictured below are two muffles used in powder metal sintering furnaces. The bottom muffle failed because the roof collapsed, which is pretty evident from the photo. Parts could not be conveyed through the muffle after the roof collapsed.

But why did the top muffle fail?

Answer: The top muffle failed because it leaked atmosphere. Both muffles were pulled out of service in under two years, causing major, unnecessary disruption for the customer.

For the above muffles, Alloy Engineering fabricated new muffles with our strengthened, corrugated design. This design is much more effective than exterior rib supports, and the new muffle will resist collapsing much better. To prevent atmosphere leaks, our muffles are welded to ASME Section IX procedures by our ASME/AWS Certified welders. Alloy Engineering's welds are prepped to ensure 100% fusion of the base metals used in our muffles. We don't rely on just a bead of weld to hold atmosphere.
